FOREST PRESERVE DETAILED PROJECT WORK PLAN

Project # 2023-WB-011

<u>Region</u> 5	<u>Project Title</u> Ragged Mountain Trail
--------------------	-----------------------------------------------

Ragged Mountain Trail

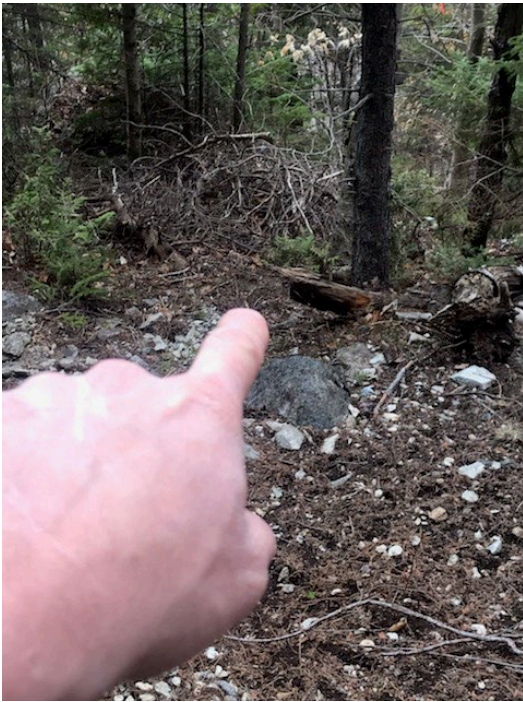
(Soil from climbing route moving downslope)

The trail will end at the base of the main face which is where the majority of the climbing routes are located. This is where the highest level of use and user congregation occurs. Soil erosion has started occurring here in an approximately 14 feet by 20 feet area at the base of the main face. Soil loss varies from 12 inches to 21 inches of depth. The average amount of soil loss appears to be about 12 inches. Photos of this can be seen in pictures below. Vegetation and soil loss will continue through natural weather events and human use if the area is not stabilized. A two-tiered approximately 14 feet by 14 feet three-sided downslope retention wall will be constructed here. The lower tier will encompass the entire social area at the bottom of the route. The upper tier will be a smaller area within the first tier located next to the wall. This will serve as the start to the routes. The tiers/crib walls will ideally be constructed of on-site rock. Given the steep and shallow soils here, mining rock may put slopes at risk. If this is the case, six by six timbers will be used to constrict the crib walls (tiers). These areas will be filled with mineral soil which will stabilize the site and provide a desirable congregation area for climbers to use. Steps may be installed to transition from the cribbed walkway area to the crib retention wall.

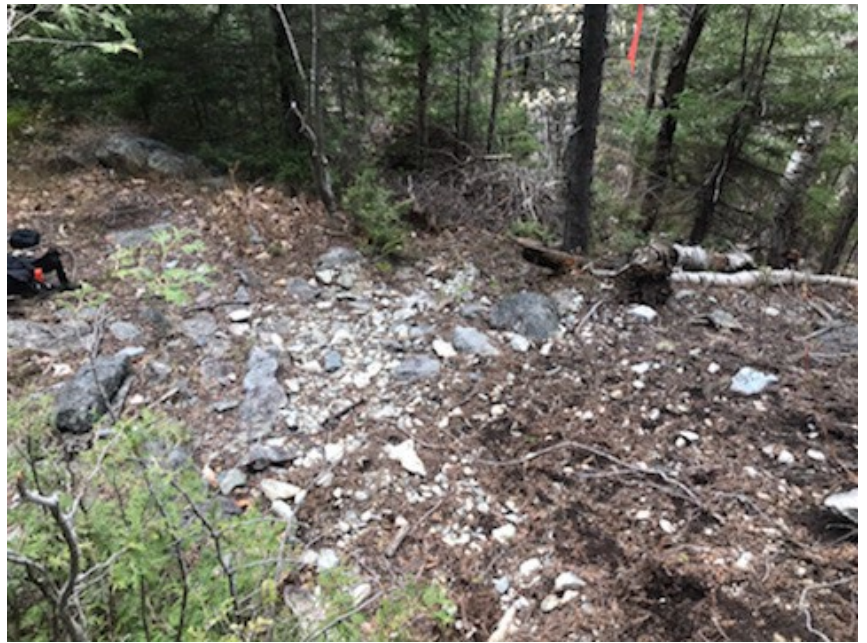
(Erosion from climbing route)

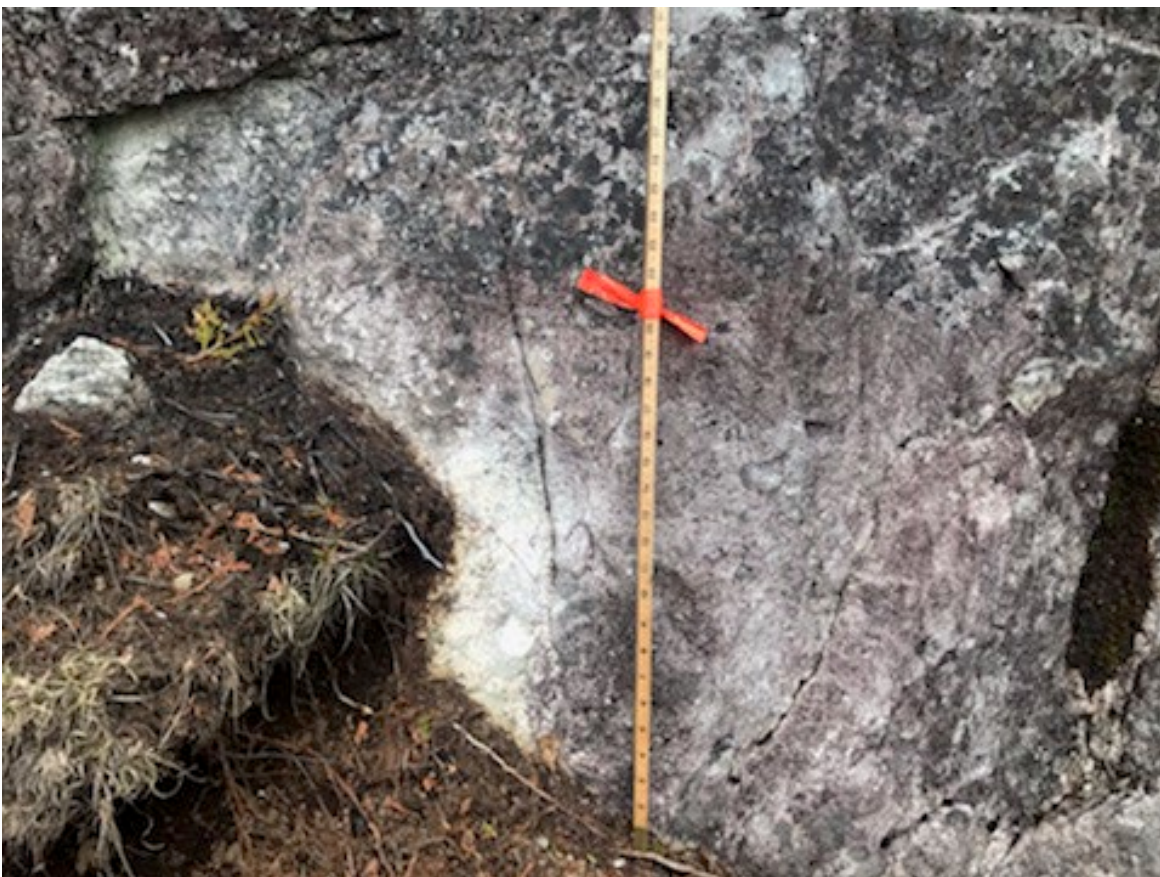
(Left side of climbing area, natural soil line marked by orange flagging. Approximately 21 inches of soil loss at this point)

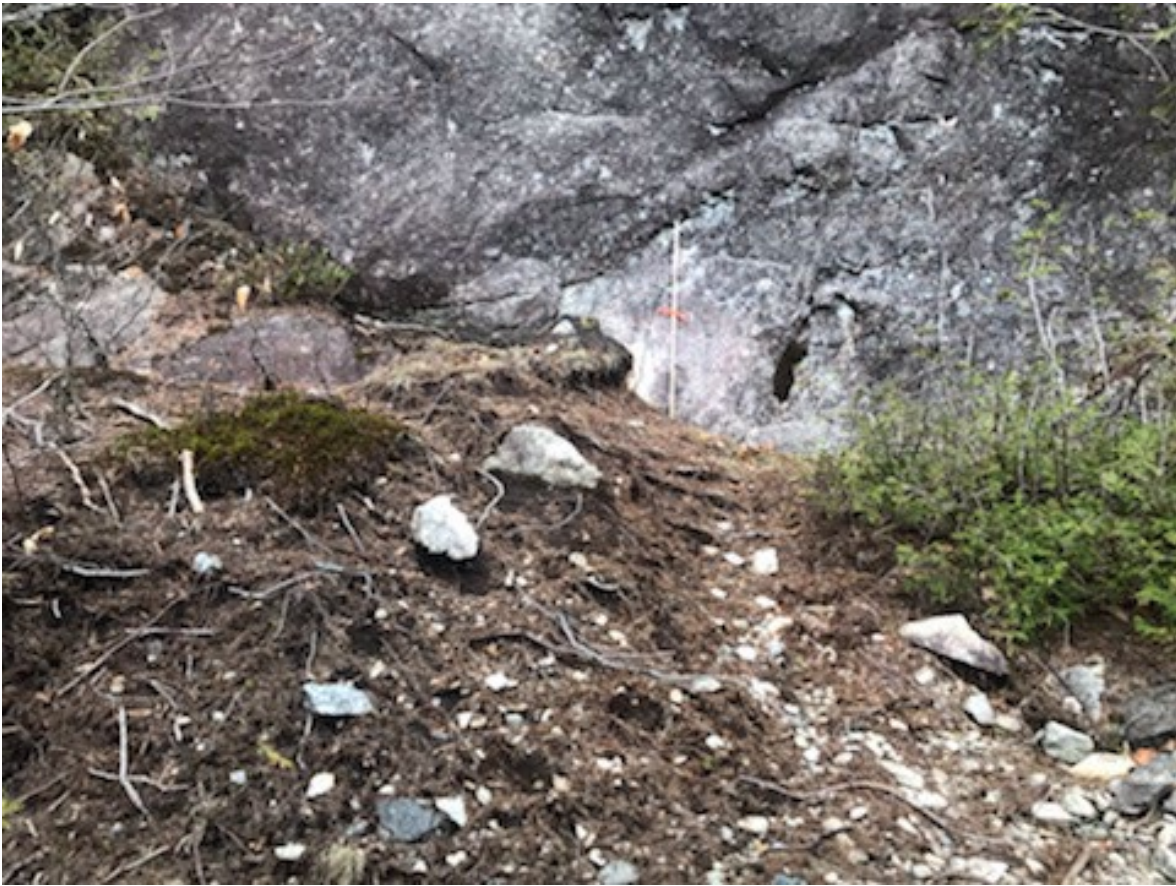
(From a distance, same 21 inches soil line as previous picture)

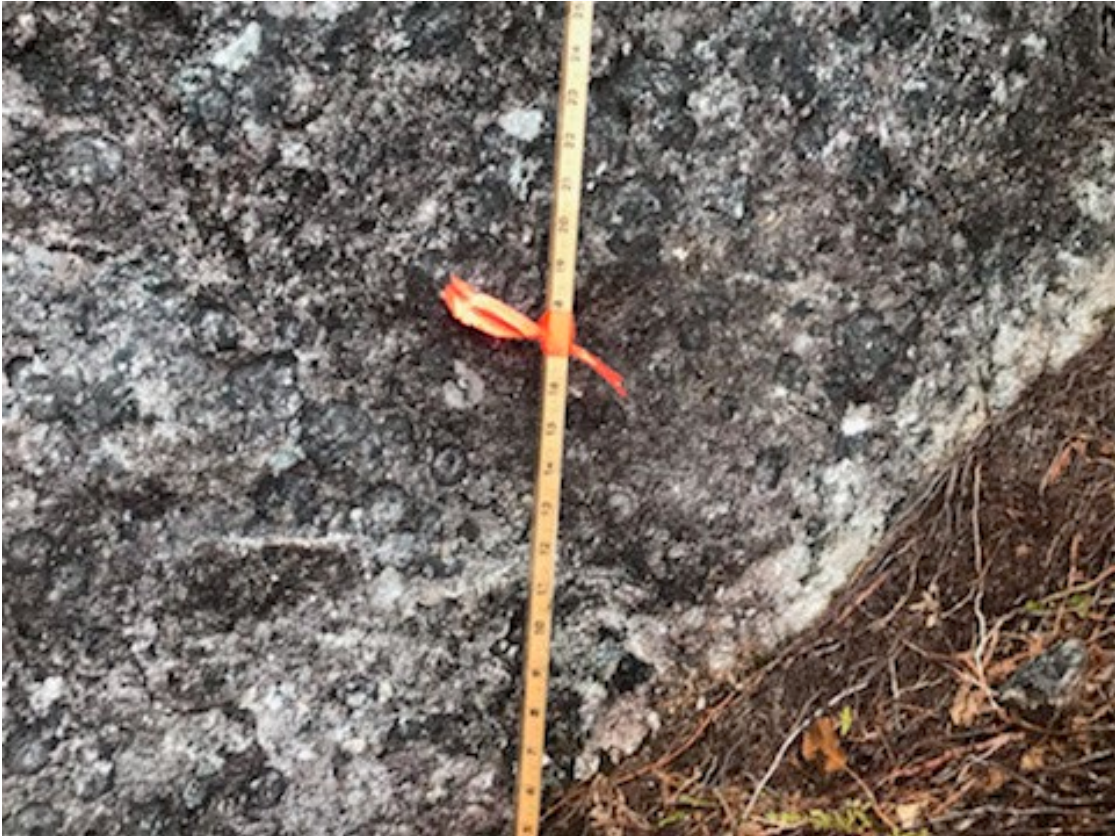
(Right side of climbing area, natural soil line marked by orange flagging. Approximately 17 inches of soil loss)

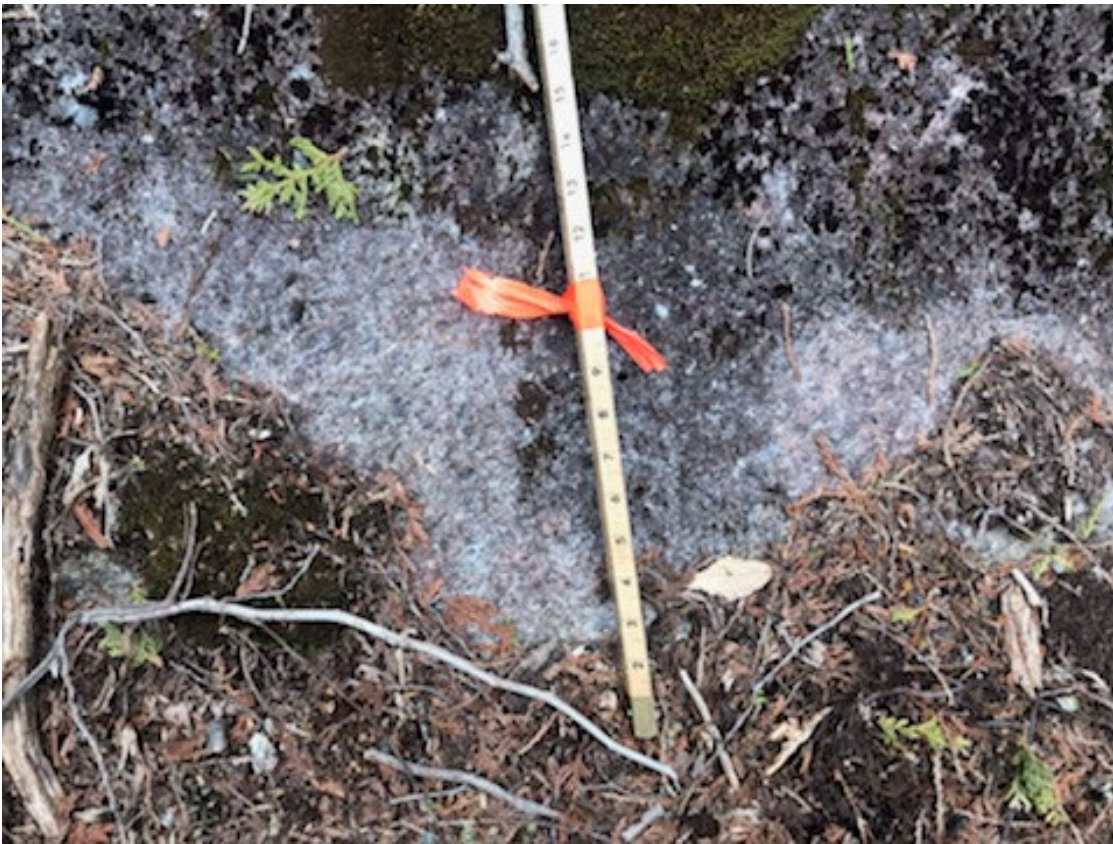
(Trail near climbing area, natural soil line marked by orange flagging. Approximately 10 inches of soil loss)

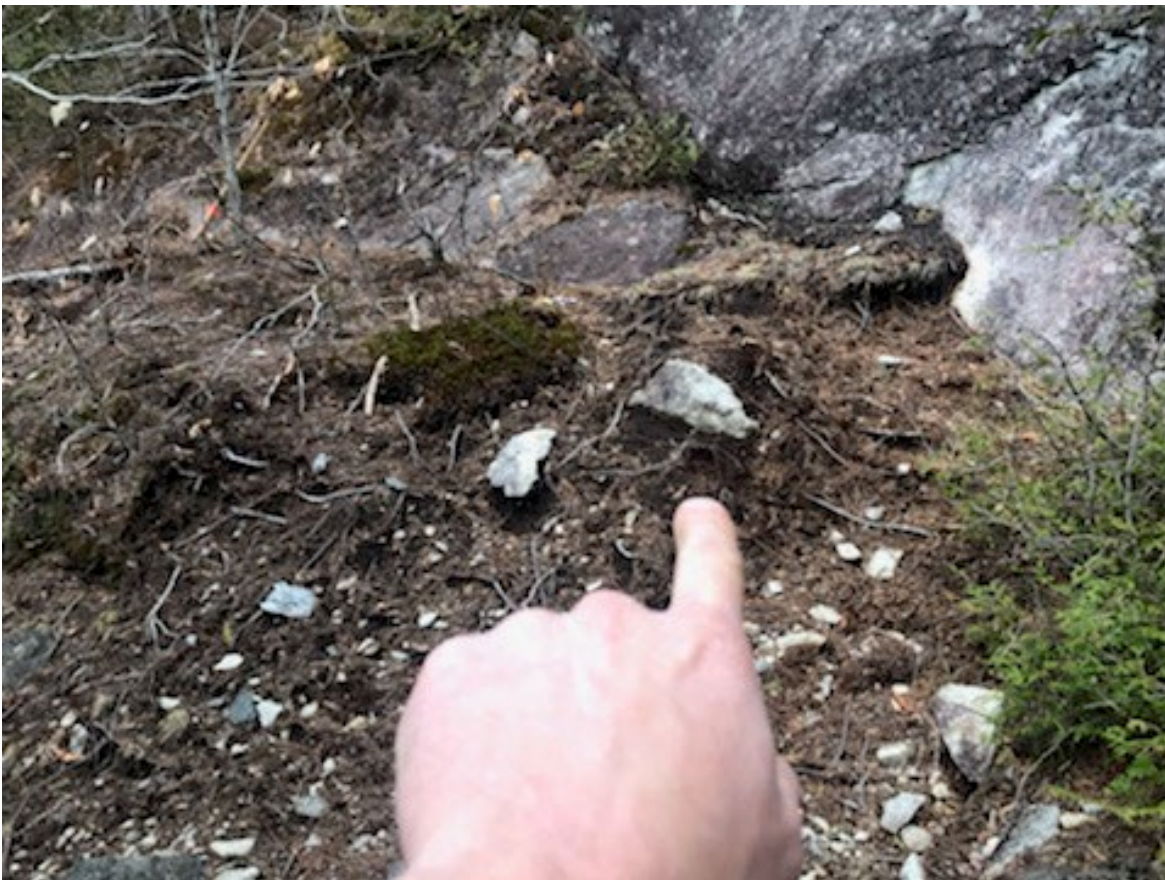
(Climbing area soil loss)

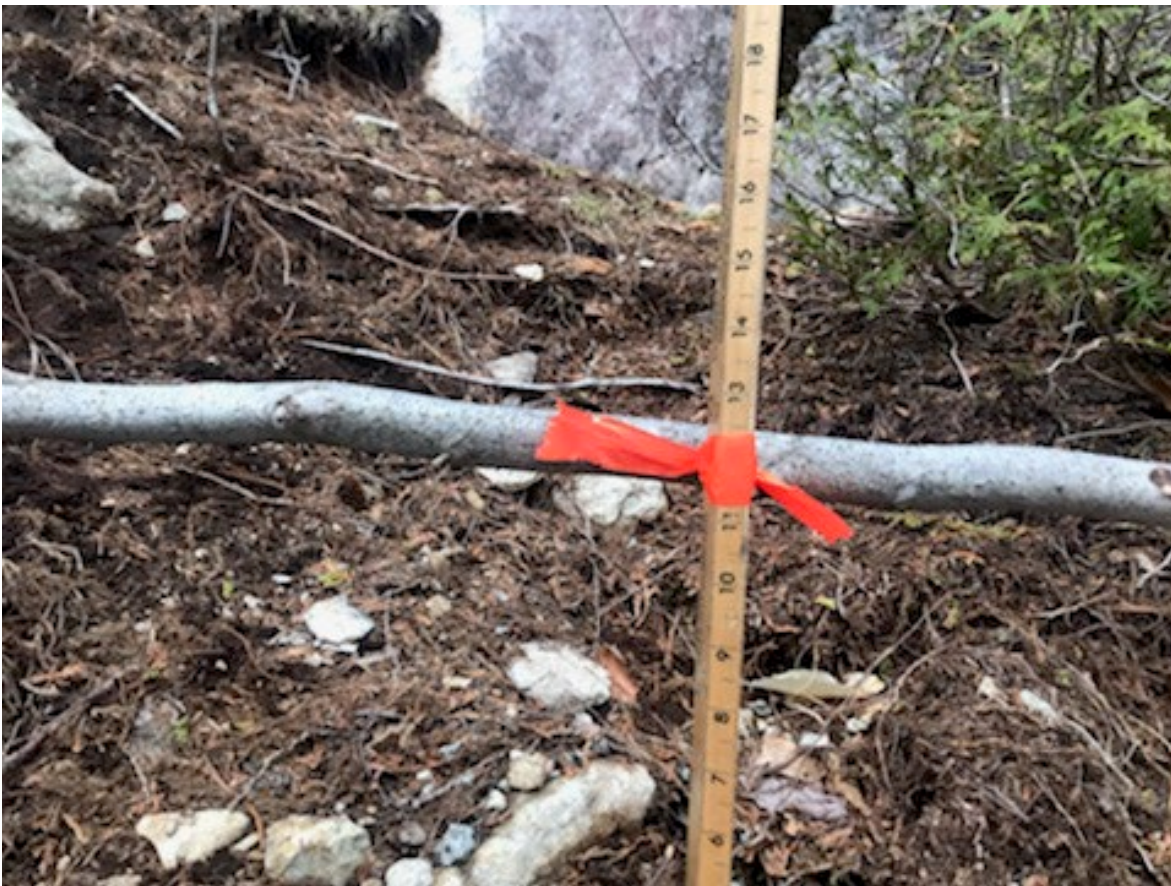
(Center of main congregation area at wall base. Twelve inches of soil loss)

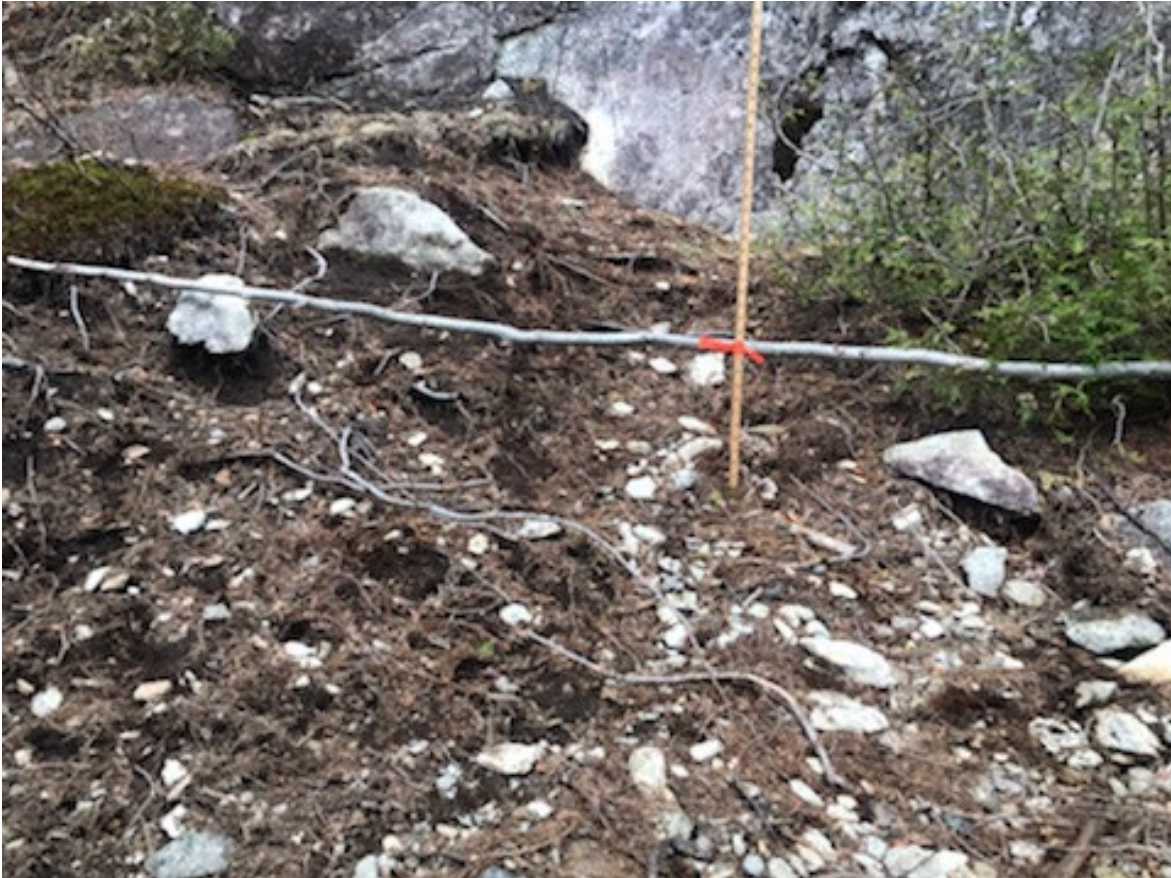
(From a distance, center of main congregation area at wall base. Twelve inches of soil loss)
